The Oerlikon EMUs - some recent learns and possibilities

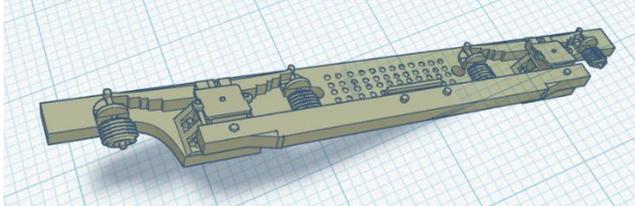
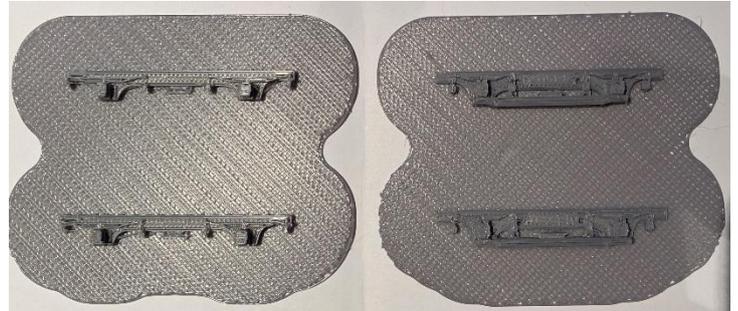
Dave has kindly used his CAD experience to draw an example motor bogie which could be 3D printed (thank you Dave). This could prove extremely helpful, though I won't rush it yet, as there's all manner of aspects I need to check before being satisfied enough to make a complete model. Here's a copy of one of the drawings, and an early version test print.

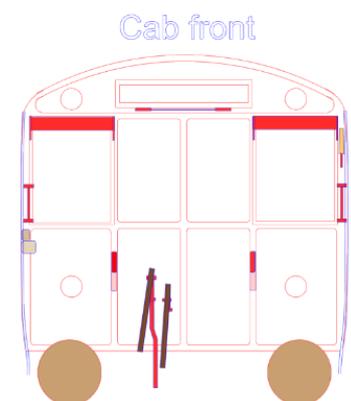
What I have managed is to scan the cab and coach ends into the Silhouette Cutter drawing programme which, with the RMWeb pictures, has enabled me to make a scale drawing.

The plain red outline is basically the etch of the cab (and panelling).

- I've marked a handrail below the indicator panel
- Window cowlings in bold red
- Whistle shown in bronze (on right sight, just below cowling)
- Small handrails either side of cab windows
- Lamp irons positioned on panel frame
- Pipework positions
- Small works plates below small handrail on left side
- The blue lines on each side of the bodywork are the rainwater pipes
- There will also be a window wiper on the window by the whistle

None of these items are provided for in the kit.

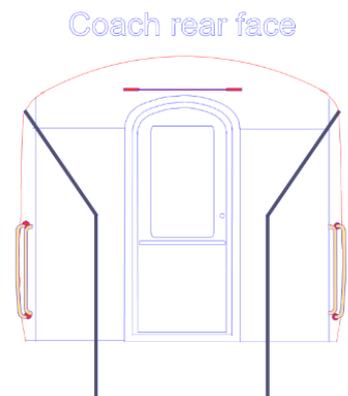
Coach ends appear to be the same throughout the set

The kit provides only a blank end

- Dark blue is rainwater pipes
- Handrail above the doorway
- All the blue lines are the visible panel joint lines, plus the doorway is recessed, which means having to cut a chunk from the fret.
- I've shown the pairs of handrails on either side purely to demonstrate their position in the side doorways which themselves are recessed at the coach end.

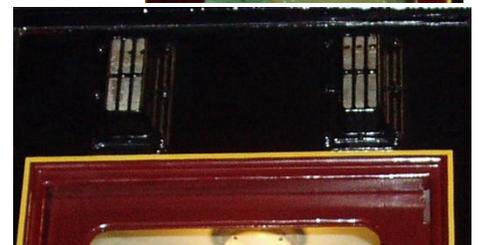
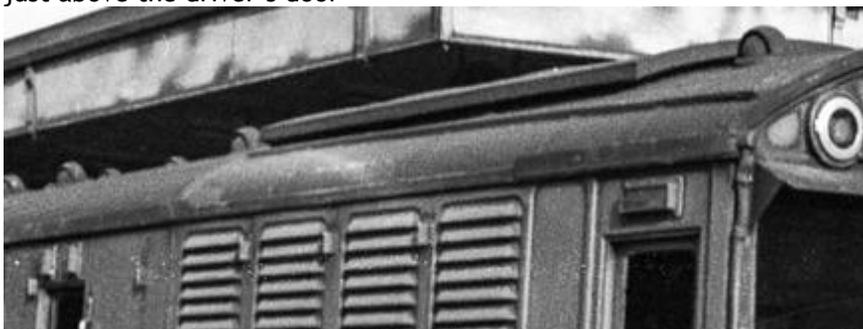
The rain strip on the roof below the electric compartment panel is there on the large majority of vehicles, one example seen apparently without. Equally, many vehicles were also fitted with a rain guard above doorways, a simple strip that appear to be rivetted to the body. The example below has both, the rain guard being visible as a darker strip just above the driver's door

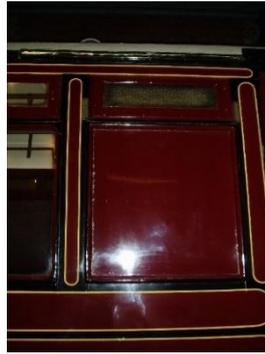
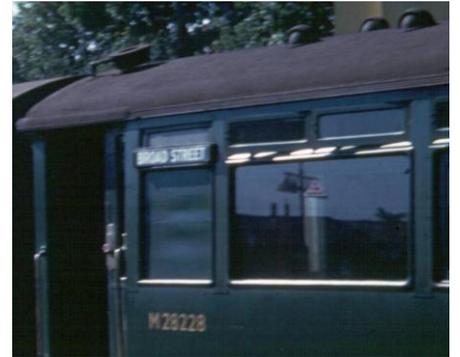
Most cars had the window adjacent to the saloon doors originally showing service indicators (eg This train is for Euston calling at....etc), but in the 1950s these had long been removed. 11 cars were never fitted with them originally, so retained a glass window, but those with the indicator removed had a wooden panel instead. This can be seen on the NRM car, and the second picture shows how destination boards were fitted outside instead.

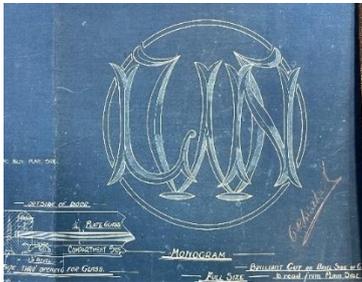
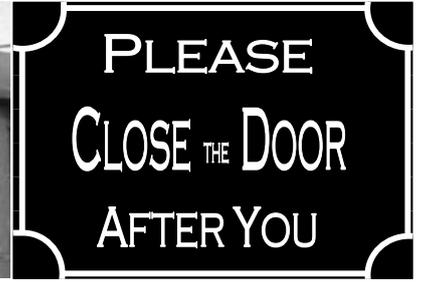
It's difficult to be certain for all vehicles, but the public doors had the LNWR monograph engraved in one of the windows as seen here, original works drawing to compare to the window on the NRM vehicle. The passenger entrances also had a sticker on the end door window with an instruction to close the door - this is my crude attempt to draw something in the style of the original.
